DEPARTMENT OF TRANSPORTATION

Quality Assurance and Source Inspection

Contract #: 04-0120F4Cty: SF/ALA Rte: 80 PM: 13.2/13.9File #: 69.28**WELDING INSPECTION REPORT****Resident Engineer:** Pursell, Gary**Address:** 333 Burma Road**City:** Oakland, CA 94607**Report No:** WIR-015368**Date Inspected:** 06-Jul-2010**Project Name:** SAS Superstructure**OSM Arrival Time:** 700**Prime Contractor:** American Bridge/Fluor Enterprises, a JV**OSM Departure Time:** 1900**Contractor:** Zhenhua Port Machinery Company, Ltd (ZPMC), Changxing Island **Location:** Shanghai, China**CWI Name:** Li Yang**CWI Present:** Yes No**Inspected CWI report:** Yes No N/A**Rod Oven in Use:** Yes No N/A**Electrode to specification:** Yes No N/A**Weld Procedures Followed:** Yes No N/A**Qualified Welders:** Yes No N/A**Verified Joint Fit-up:** Yes No N/A**Approved Drawings:** Yes No N/A**Approved WPS:** Yes No N/A**Delayed / Cancelled:** Yes No N/A**Bridge No:** 34-0006**Component:** OBG Segment**Summary of Items Observed:**

Segment 9BE/9CE

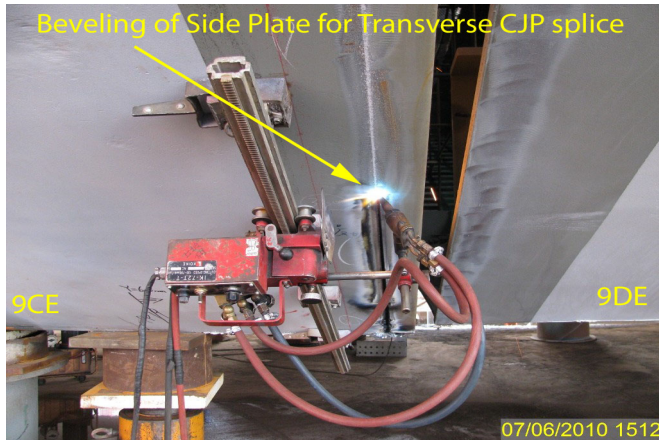
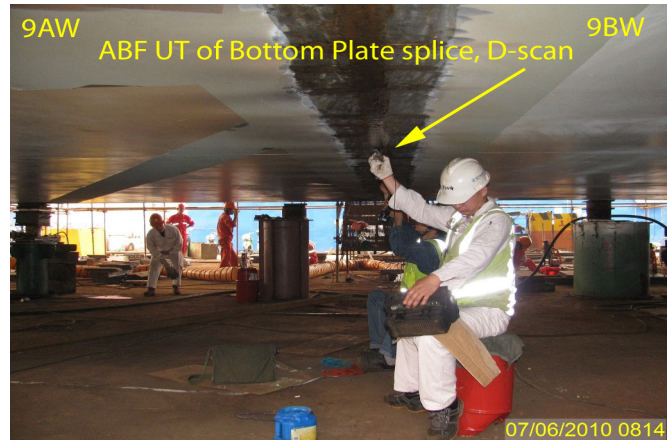
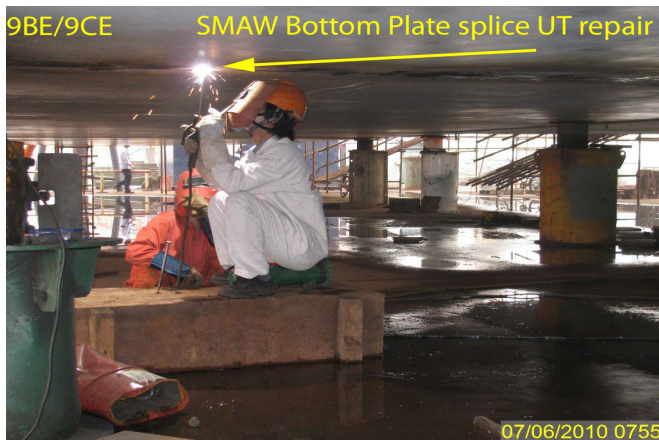
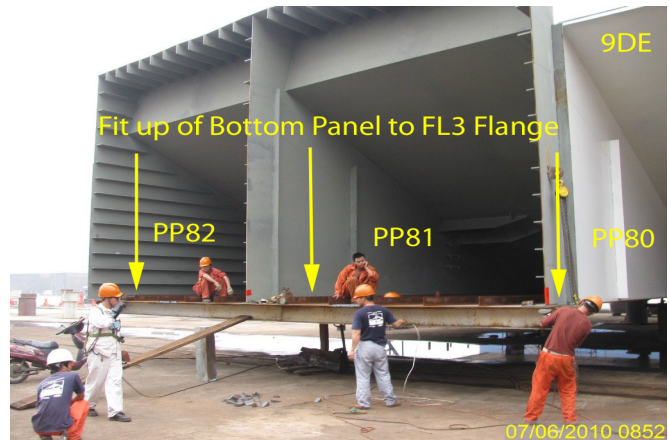
This QA Inspector observed Shielded Metal Arc Welding (SMAW) in progress of a Complete Joint Penetration (CJP) weld joint. The Weld joint is designated as OBE9B-008, Bottom Plate Splice. The welder is identified as #054467 and was observed welding in the 4G (overhead) position using approved Welding Procedure Specification WPS-345-SMAW-4G (4F)-FCM-repair-1, UT repair for WR13918.

This QA Inspector observed Base Metal Repair using the Shielded Metal Arc Welding (SMAW) process at locations of removed fit up plates along the exterior of the Edge Plate transverse CJP splice. The welder is identified as #048659 and was observed welding in the 2G (horizontal) position using approved Welding Procedure Specification WPS-345-SMAW-2G (2F)-FCM-repair-1 for WR13193.

This QA Inspector observed Shielded Metal Arc Welding (SMAW) in progress of a Complete Joint Penetration (CJP) weld joint. The Weld joint is designated as OBE9-006, Edge Plate Splice. The welder is identified as

This QA Inspector observed Shielded Metal Arc Welding (SMAW) in progress of a Complete Joint Penetration (CJP) weld joint. The Weld joint is designated as DP698-001-019, Deck Plate I-rib Splice. The welder is identified as #053753 and was observed welding in the 3G (vertical) position using approved Welding Procedure Specification WPS-485-SMAW-3G (3F)-FCM-repair-1, UT repair for WR13934.

This QA Inspector observed Shielded Metal Arc Welding (SMAW) in progress of a Complete Joint Penetration (CJP) weld joint. The Weld joint is designated as CA055-005 and CA059-001, Deck Plate to Edge Plate. The welder is identified as #045196 and was observed welding in the 1G (flat) position using approved Welding Procedure Specification WPS-B-P-2211-TC-U4b-FCM-1.
